**COUNTY OF SAN MATEO  
PLANNING AND BUILDING DEPARTMENT**

**SUBJECT:** EXECUTIVE SUMMARY: Consideration of an After-The-Fact Grading Permit for the restoration of a coastal bluff involving approximately 7,200 cubic yards of balanced cut and fill grading, located at 20165 Cabrillo Highway, a developed parcel in the unincorporated San Gregorio area of San Mateo County. This project is located in the Cabrillo Highway State Scenic Corridor. The required Coastal Development Permit for this project is under the permitting authority of the California Coastal Commission.

County File Number: PLN 2013-00495 (Kerry Burke)

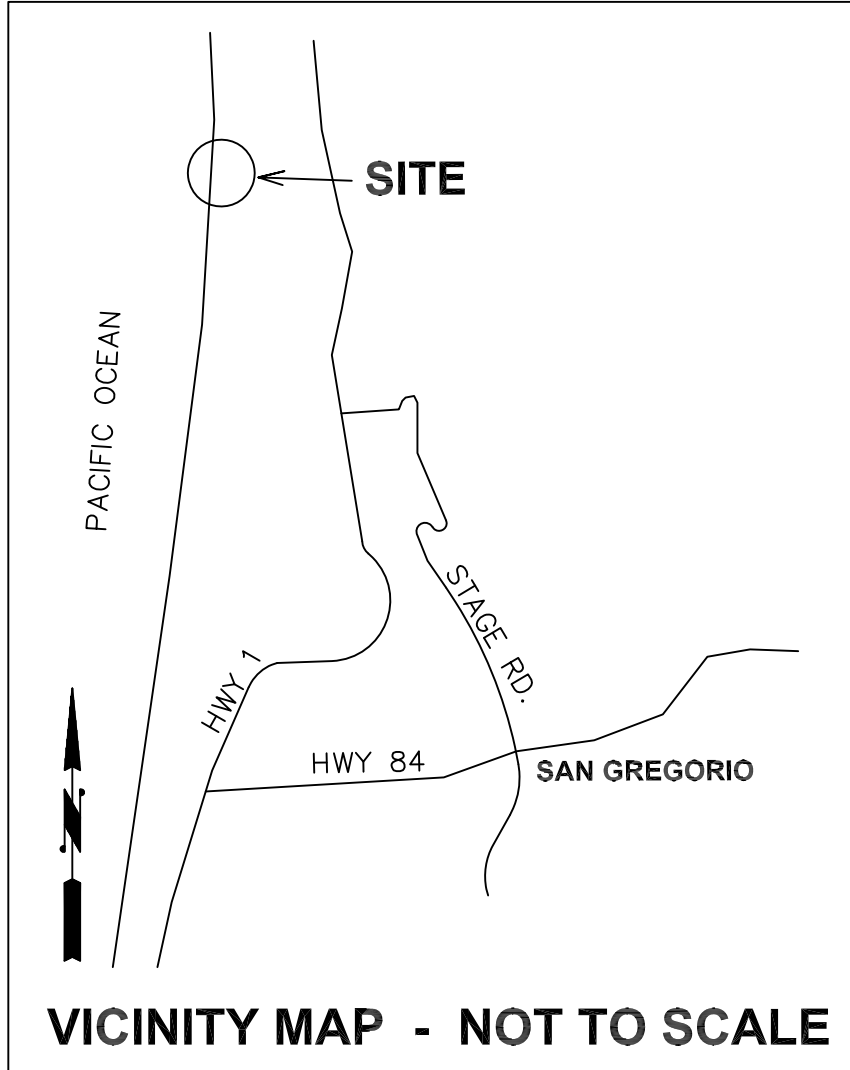
1. EROSION CONTROL MEASURES THAT WERE PLACED IN 2013 PERFORMED AS PLANNED. THE SITE HAS EXPERIENCED NO EROSION AND VEGETATION IS NOW WELL-ESTABLISHED. THERE IS NO LONGER A NEED FOR EROSION CONTROL MEASURES.
2. INSPECTIONS WERE PERFORMED AT THE END OF EACH RAINY SEASON TO OBSERVE THE CONDITION OF THE RESTORED AREA.
3. ALL DRAINAGE NATURALLY OCCURRING WITHIN RESTORATION SITE. NO ADDITIONAL FACILITIES REQUIRED.
4. PLANS PREPARED AT THE REQUEST OF: CHHMB, LLC OWNER REPRESENTATIVES.
5. ORIGINAL SURVEY AND TOPOGRAPHY BY SIGMA PRIME, JULY 16, 2013.
6. ELEVATION DATUM ASSUMED.
7. AS-BUILT CONDITIONS BASED ON OBSERVATIONS MADE ON APRIL 21, 2017.

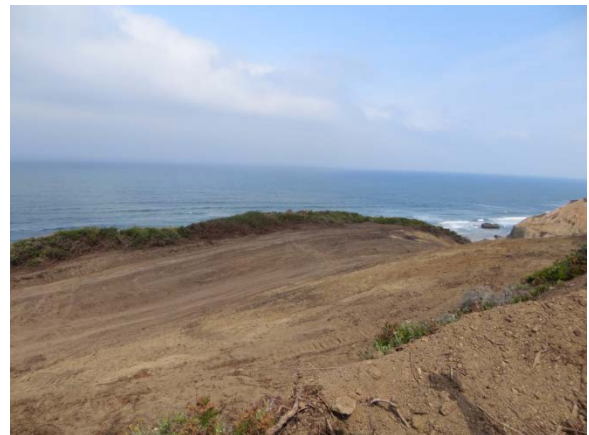
During the initial site visit, Ms. Leslie Lazarotti of WRA walked the area of the grading and earthmoving activities (repair area). Adjacent habitat consisted of northern coastal scrub dominated by coyote brush (*Baccharis pilularis*) and is considered as a common shrubland alliance on the California coast. Canopy cover in undisturbed portions of the property was nearly 100 percent with species cover and density similar to that reported by Baxter and Parker (1999) in their study on coastal scrub communities of the San Mateo coast (see photograph to the right). No wetlands, streams, or riparian habitat were observed in the area of the earthwork (WRA 2013).

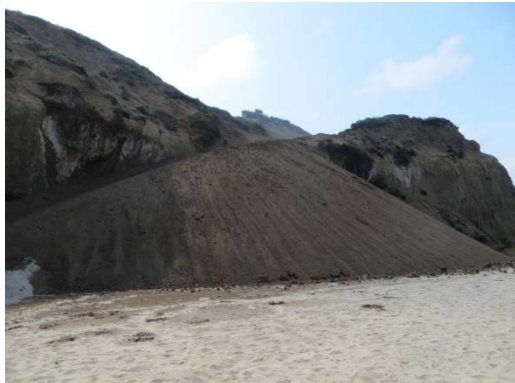
Following the coastal bluff restoration and repair work, WRA conducted site visits to assess the progression of vegetation maturation within the restored area. A total of eight site visits were conducted by WRA between 2014 and 2017: February 21, April 11, and August 25, 2014; April 9 and June 29, 2015; June 3, 2016, and January 19 and May 1, 2017.

Over the course of four years, the restored site has progressively increased in vegetative cover, with a heavy dominance on native plant species. Site visit summaries are described in Table 2. An observed species list for the restored area is included in Attachment B. A comprehensive set of timeline photos are included in

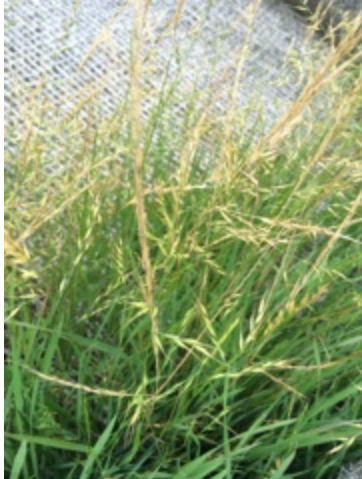
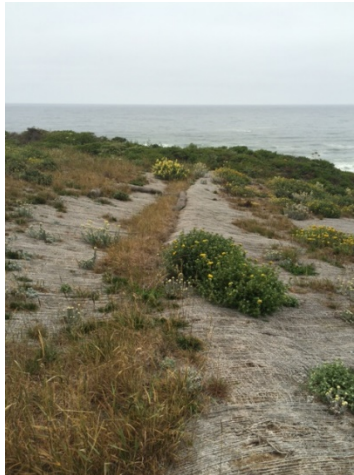
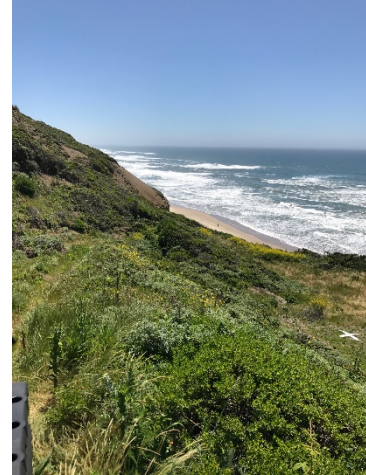
Photographs: 1) Three week fescue observed within the restored area on April 11, 2014. 2) Drainage furrows, observed during the June 24, 2015 site visit. 3) Completely vegetated section of the site along a steep slope, including a mix of meadow barley, seaside woolly, yellow bush lupine, poison oak, coyote brush, and others observed during the May 1, 2017 site visit.

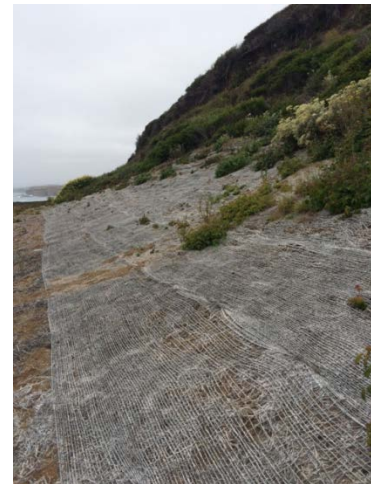
Following repair and restoration activities during the fall of 2013, the restored area has steadily increased in percent cover of vegetation and is currently dominated by the following native species: meadow barley, seaside woolly, yellow bush lupine, poison oak, and coyote brush. Of the species consistently documented as dominants within the restored area, meadow barley was the only species included as part of the seed mix applied to the site. Seaside woolly sunflower, yellow bush lupine, poison oak, and many of the subdominant plant species present on the site are typically found in coastal scrub communities and were not included in the seed mix. Thus, these species were naturally recruited, either by the existing seedbank or local dispersal, into suitably restored habitat conditions. Non-natives present within the restored area include tall fescue (*Festuca arundinacea*), sea fig (*Carpobrotus chilensis*), bull thistle (*Cirsium vulgare*), and common mustard (*Brassica rapa*).

The plant species composition within the restored area is comparable to the composition of surrounding coastal scrub habitat. In addition, over the course of the four years of monitoring, steady plant growth was observed and the restored area is considered as densely vegetated as the surrounding coastal scrub habitat (Attachment C). The natural successional processes were first observed on the edges of the restored area; new recruits of coast sagebrush (*Artemisia californica*), coyote brush, and California blackberry (*Rubus ursinus*) are occurring in a concentrated fringe along the outer edge (see photograph to the right). This then spread throughout the site, allowing for full regrowth to occur.

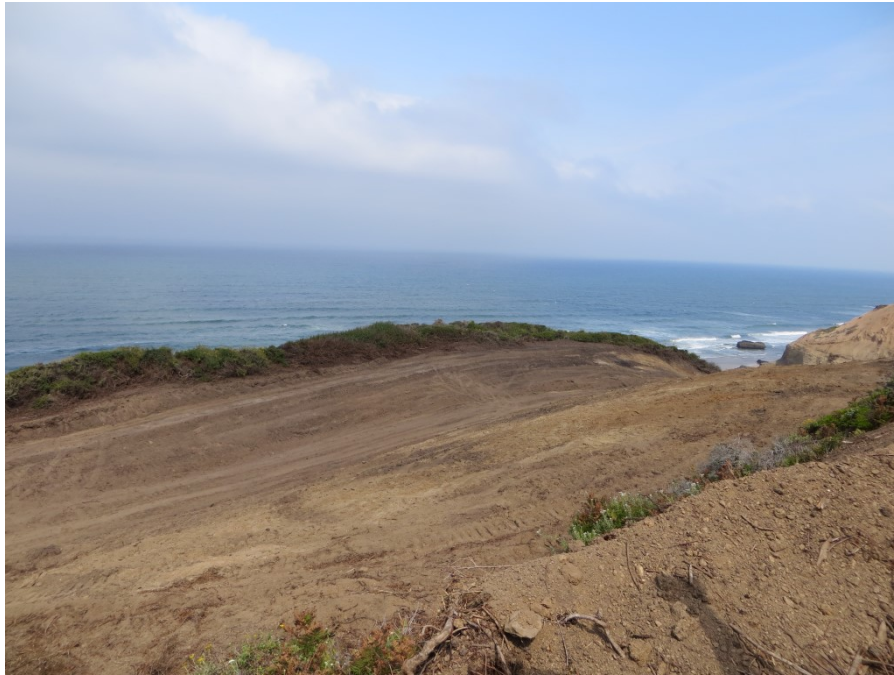
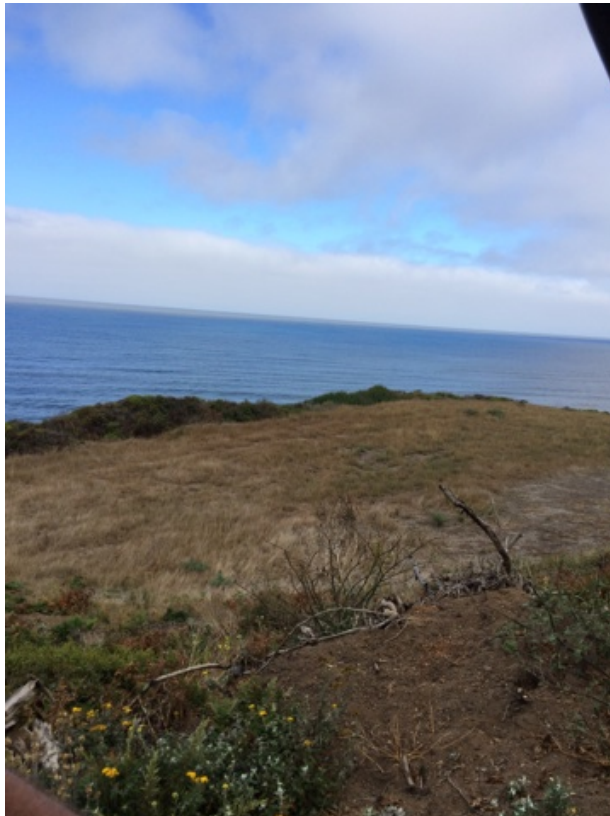
Above: July 29, 2013; Overlooking the graded area along the coastal bluff.

Below: August 25, 2014; Just over one year later, the coastal bluff has been restored and native vegetation has established.

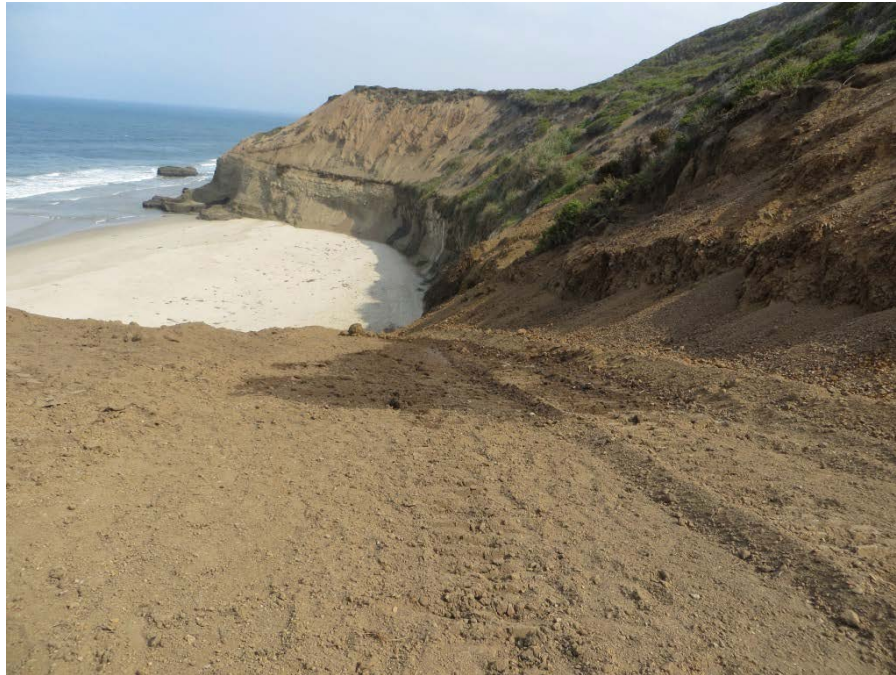
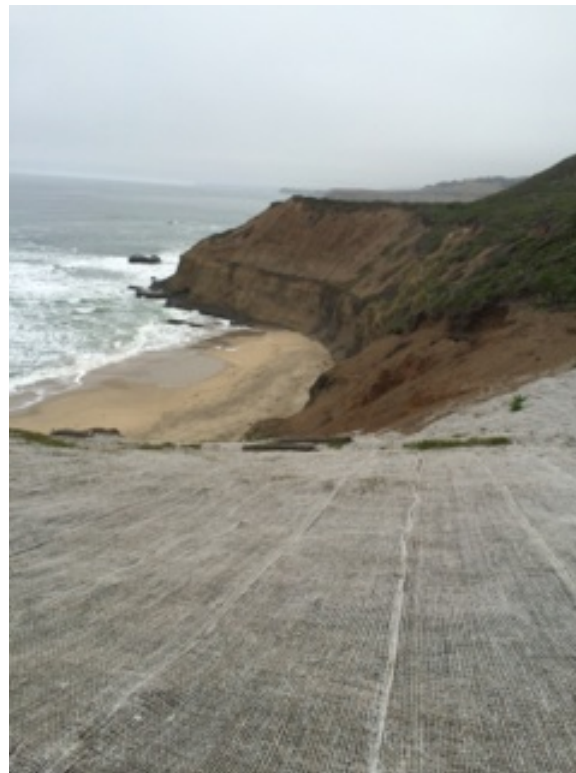
Above: July 29, 2013; The graded slope down to the beach was stripped of vegetation.

Below: April 11, 2014; The slope to the beach has been stabilized and small amounts of vegetation and grass are emerging through the erosion control material.

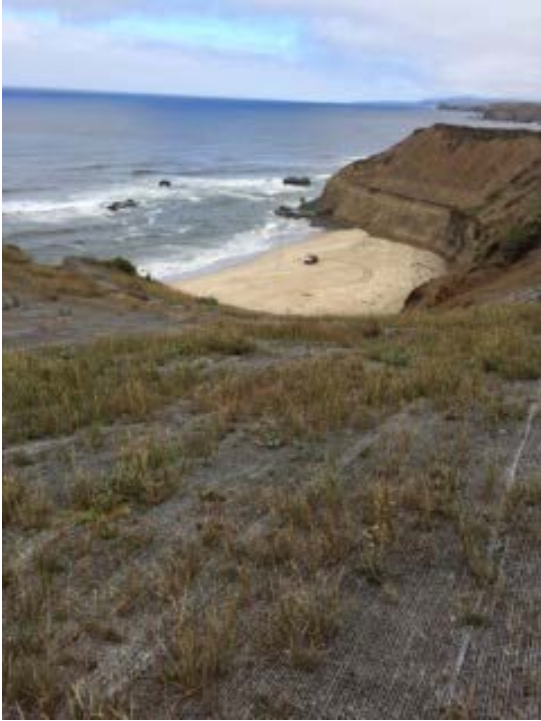
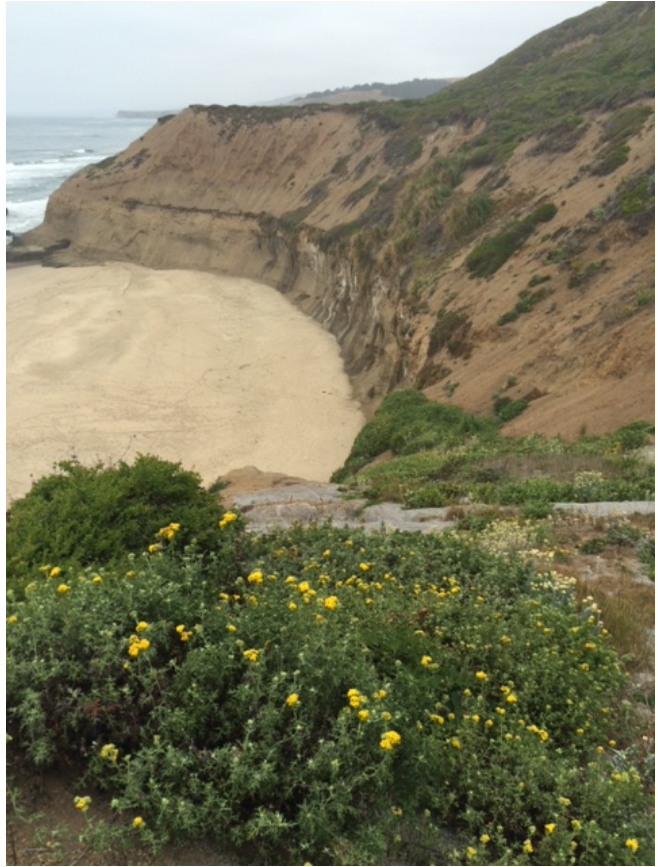
Above: August 25, 2014; The amount of vegetative cover on the slope to the beach continues to increase.

Below: June 24, 2015; Native shrubs are now established down the slope to the beach, increasing hillside stability.

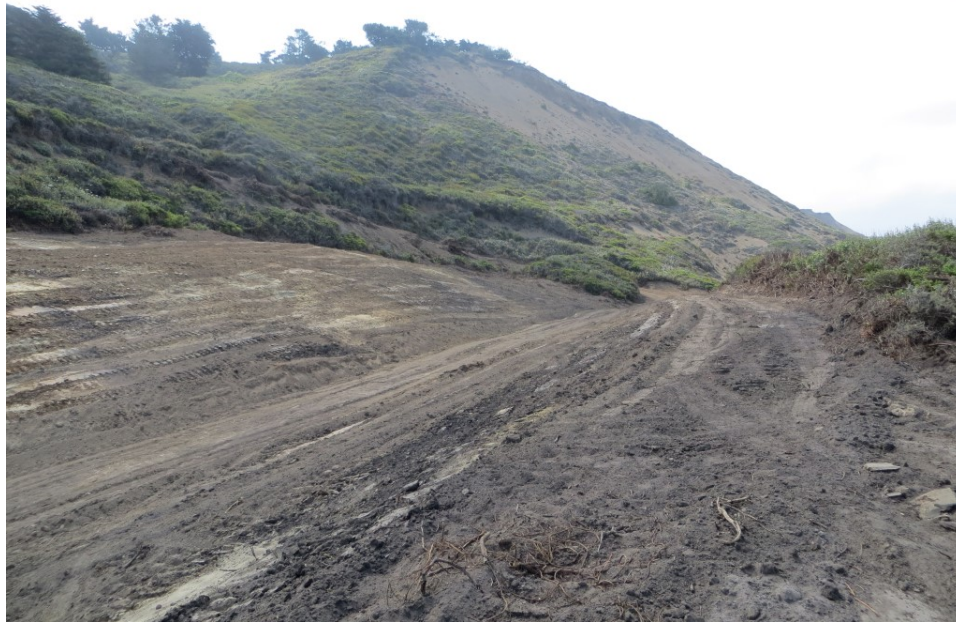
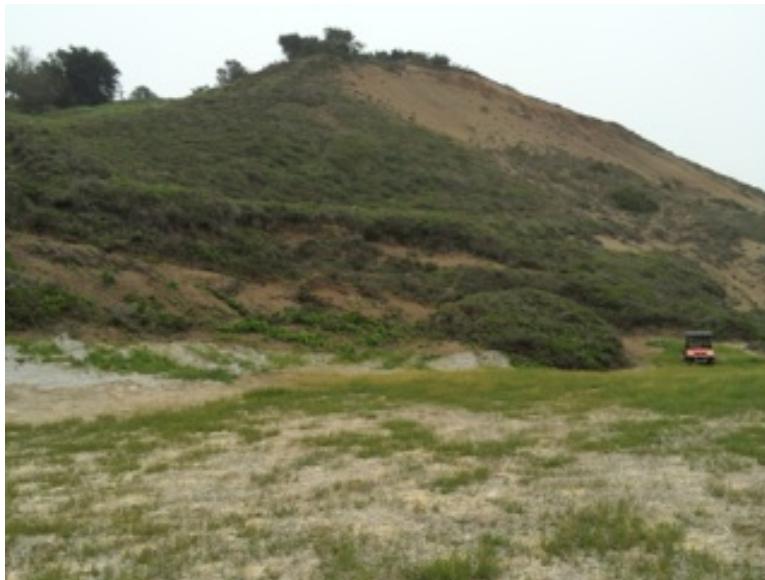
Above: July 29, 2013; the site was thoroughly stripped of all vegetation and graded to a lower elevation.

Below: April 11, 2014; As evidenced, repair actions have restored the elevation to the site and the initial growth from the applied seed mix is occurring.

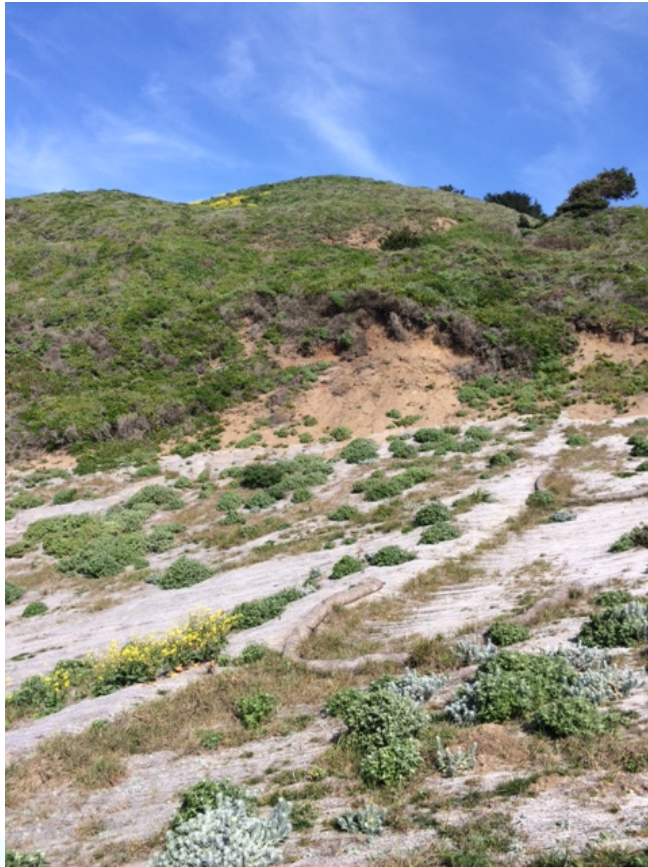
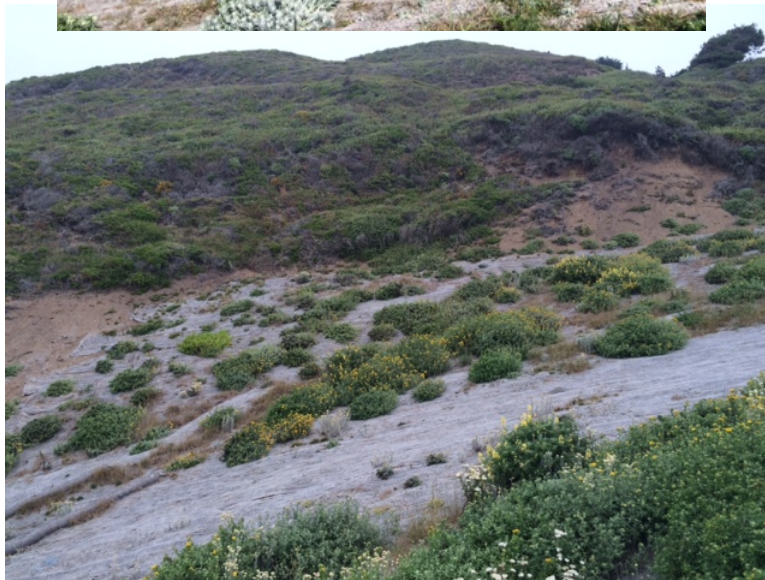
April 9, 2015 (above) and June 24, 2015 (below). The juxtaposition of these two photographs shows native shrub growth over two months. Seaside woolly sunflower, coyote brush and poison oak from the adjacent coastal scrub habitat have become established in the restored area. In addition, the furrows crossing the area are becoming vegetated.

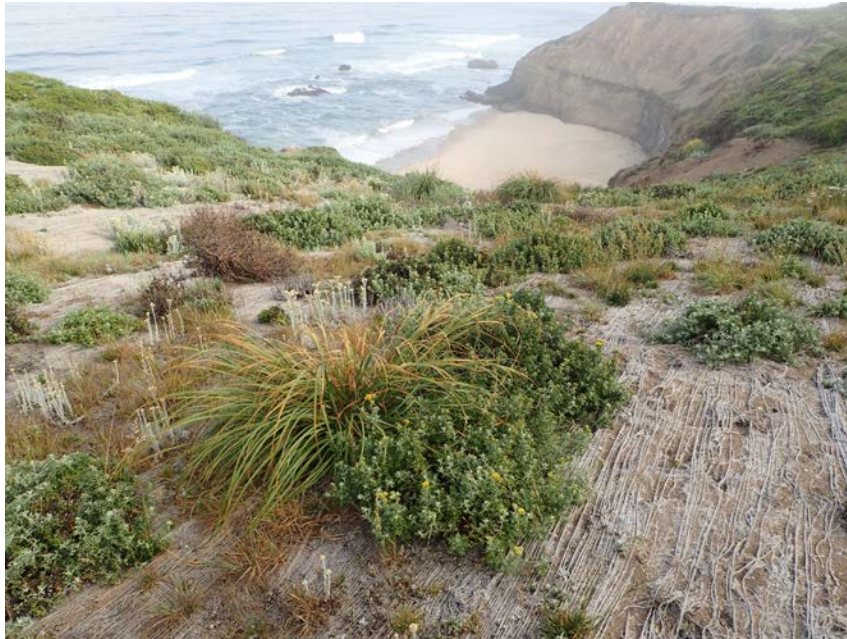
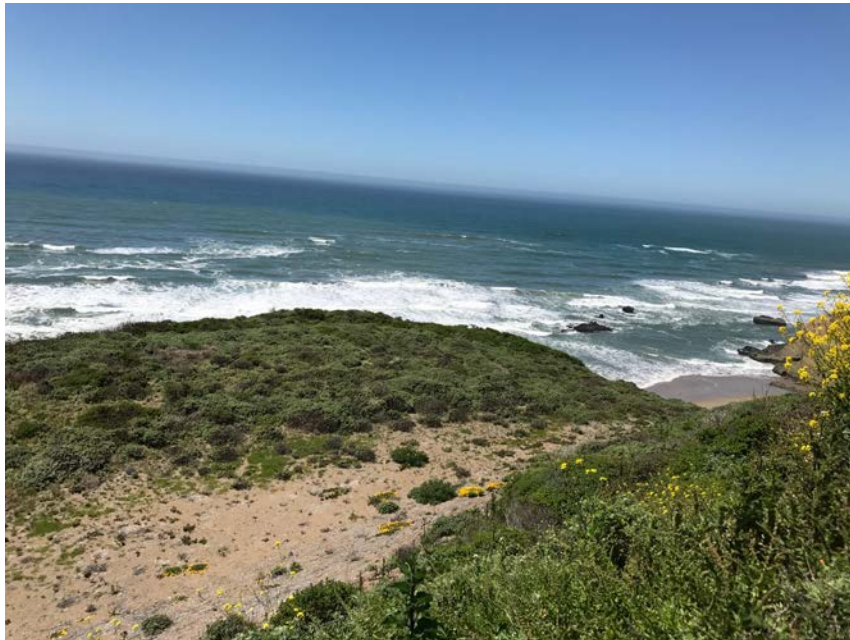
Above: June 3, 2016. The amount of vegetation along the sloped site continues to increase.

Below: May 1, 2017. The same area as above represents full regrowth of coastal shrub, consistent with the vegetated state of the surrounding lands.
